THE SPROTIA EXPEDITION II ENVIRONMENT AND SETTLEMENT PATTERNS

Further Observations on the Hellenistic Fortifications in the Kokytos Valley

Mikko Suha

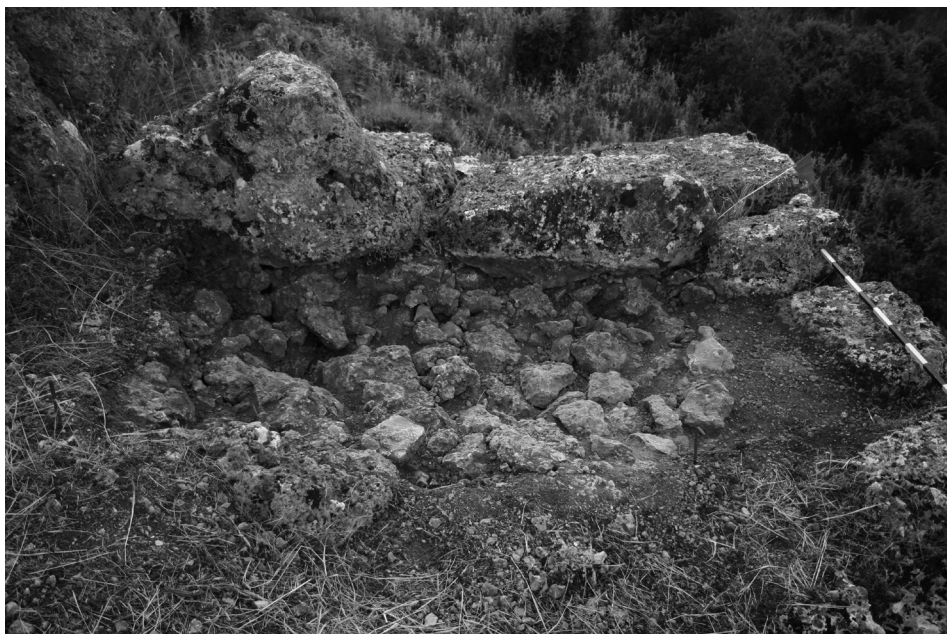
Fig. 7. The straight-angle corner, view towards southeast. The loose rubble filling and the lowermost inner face blocks of the narrow corner wall are visible. The block adjacent to the flag has traces of the adjoining wall.

Immediately after removing a few cm of topsoil in a trench in the very corner, a continuous layer of rubble was exposed all over the trench at an elevation of 231.31-231.53 masl (Fig. 7). These roughly fist-to-head-sized stones were loosely laid, with practically no soil in between. I am inclined to think that this is the original structure of the corner; large, heavy blocks making up the outside facing were carefully laid for support, while the space between the outer wall and the natural bedrock slope was filled in with loose stones in order to form a level surface in the interior. It was common practice to construct such features; the loose fill with no soil would have let the water seep through quickly, in this way not endangering the stability of the corner.²⁰

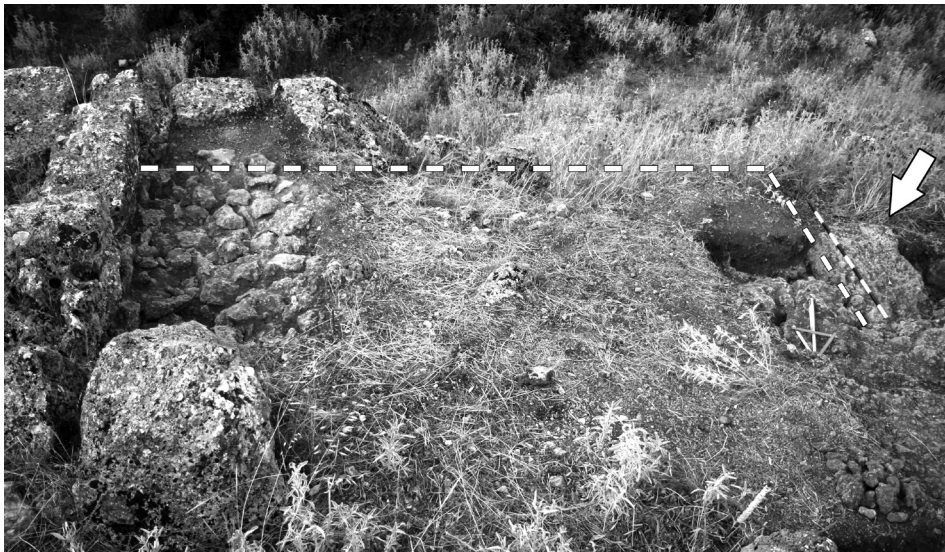
Fig. 9. The straight-angle corner, view towards south. To the left is the rubble fill; to the right, pointed by the arrow, is the large block. Dashed line indicates the location of the inside faces of walls. The *cocciopesto* floor, poured directly on top of the original rubble fill, is visible underneath the north arrow. The landslide is visible on the right-hand side.

as everything behind it had tumbled downhill, eradicating all traces of curtains in the area (Fig. 9). The top of the newly found block was located at ca. 230.15 masl, which is approximately 1.20 m below the level of the first trench and up to 1.5 m below the assumed floor level.

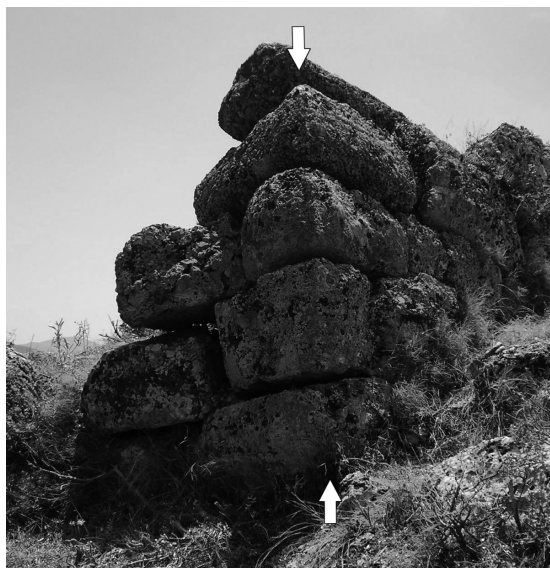
Fig. 14. The exterior corner of the tower, seen from the north. Note the faintly visible traces of drafting along the vertical edges of the blocks, indicated by arrows.

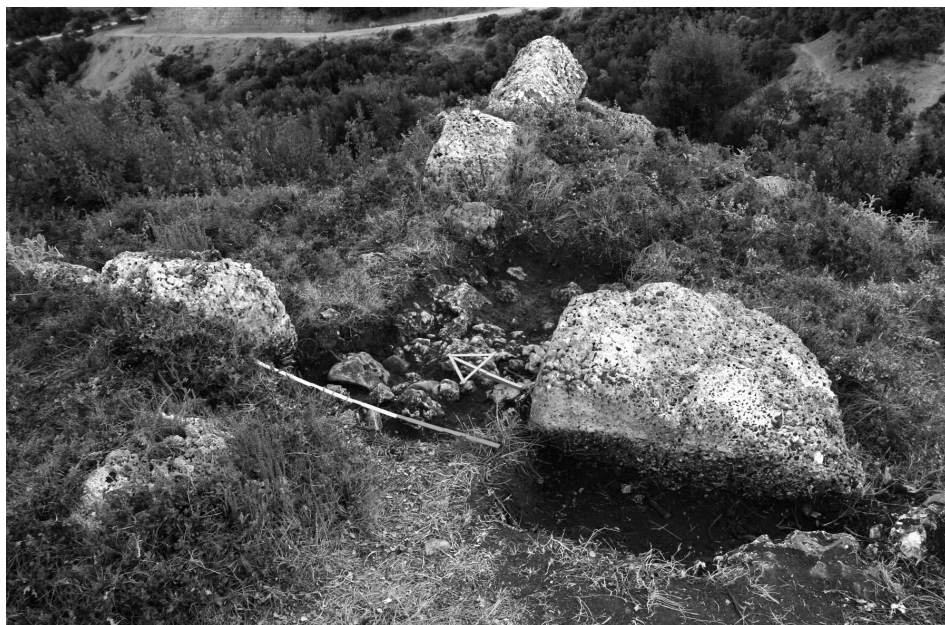
Fig. 15. The tower and trench A seen from within the fortress towards northeast. The outer face of the curtain can be seen to the left and the best-preserved exterior corner of the tower is visible in the upper part of the picture. The large block in the foreground is from the original southern wall of the tower, fallen on its side. The stone filling of the base can be seen in the trench.

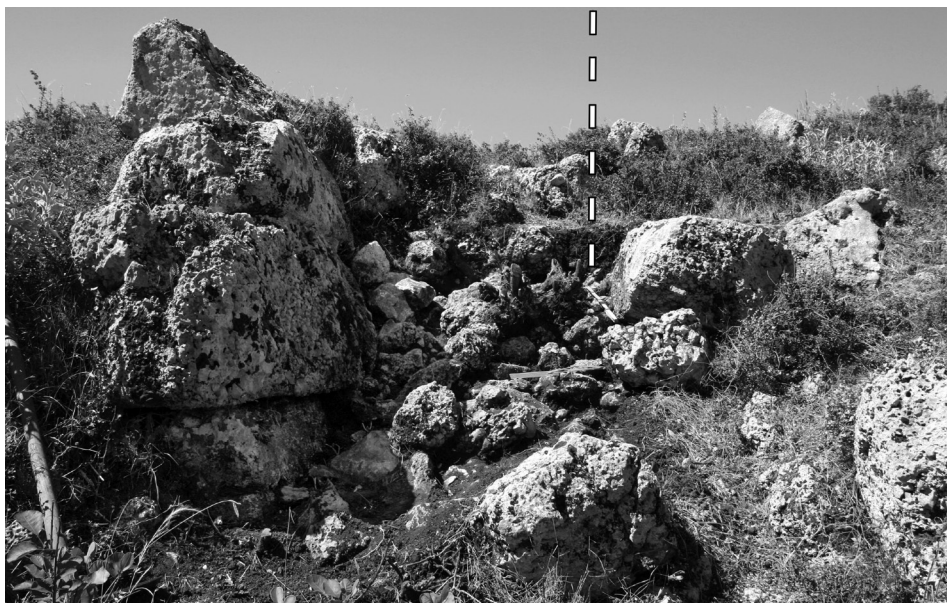
Fig. 16. The gateway seen from the outside, towards south-southeast. The better preserved eastern wall is on the left, whereas the western wall consists of only one fallen block, whose original position is indicated by a dashed line. The gate corridor in the middle is blocked by loose stones probably originating from the filling of the adjacent curtains.

In trench B, on the other hand, it was possible to excavate deeper, on the uphill side up to 70 cm, whereas on the downhill side the bedrock was quickly reached. The fortifications are badly preserved, but they still consist of up to four stone courses on the eastern side of the probable gate (Fig. 16). On the western side there were no preserved
