THESPROTIA EXPEDITION III LANDSCAPES OF NOMADISM AND SEDENTISM

The Walls of Elea: Some Thoughts Concerning their Typology and Date

Mikko Suha

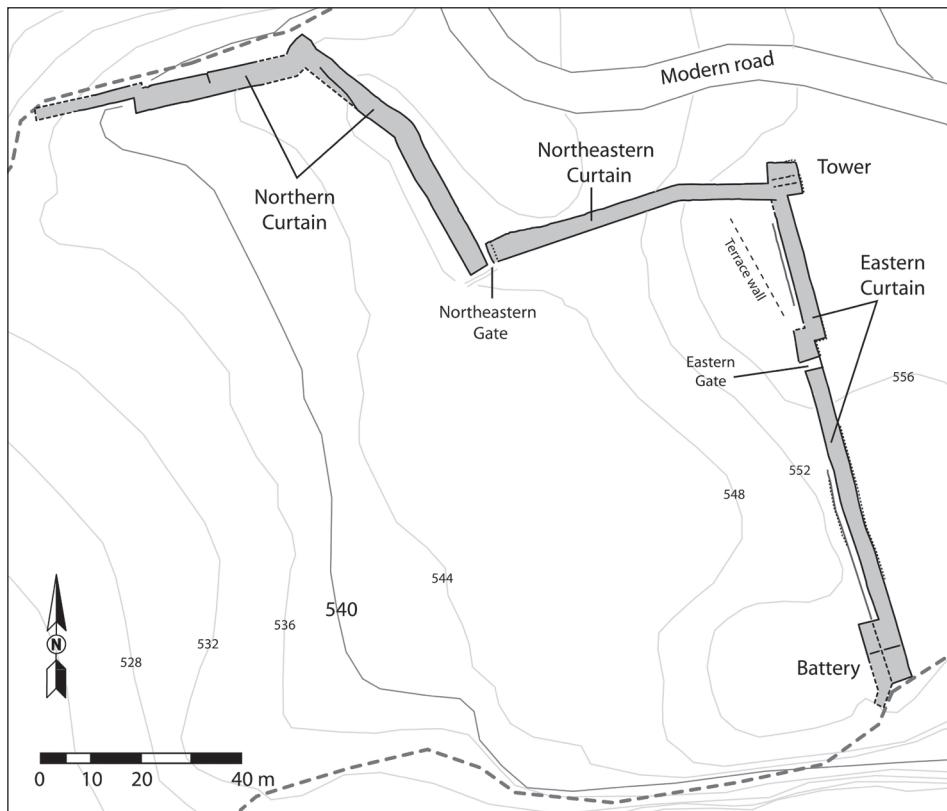
Fig. 1. The walls of Elea. The presumed course of walls, now lost, and structures embedded within the present fortifications have been drawn with dashed line.

covering all the approaches from the mountainside (Fig. 1). The city centre, including the agora and most of the civic buildings, is located on a lower terrace at an altitude of around 500-520 masl, while the westernmost extremity of the city and its western gateway is located still lower, at 476 masl. The circumference of the site is ca. 1410 m, and the fortified city area covers some 10.5 ha.⁶

From the tower, the wall runs in a westerly direction for 17.9 m after which there is a slight change of direction towards west-southwest for another 40.2 m. The eastern half of this northeastern curtain is in good shape, in places still reaching up to 6 m, but as the wall runs west it is less well preserved, attaining a height of some 1.5-2 m (Fig. 5). The western end of the curtain was, until a few years ago, covered by a huge mass of tumbled blocks, since removed. After the loose blocks were removed, the outer face of the wall has bulged outwards, resulting in an irregular appearance in plan (Fig.1).

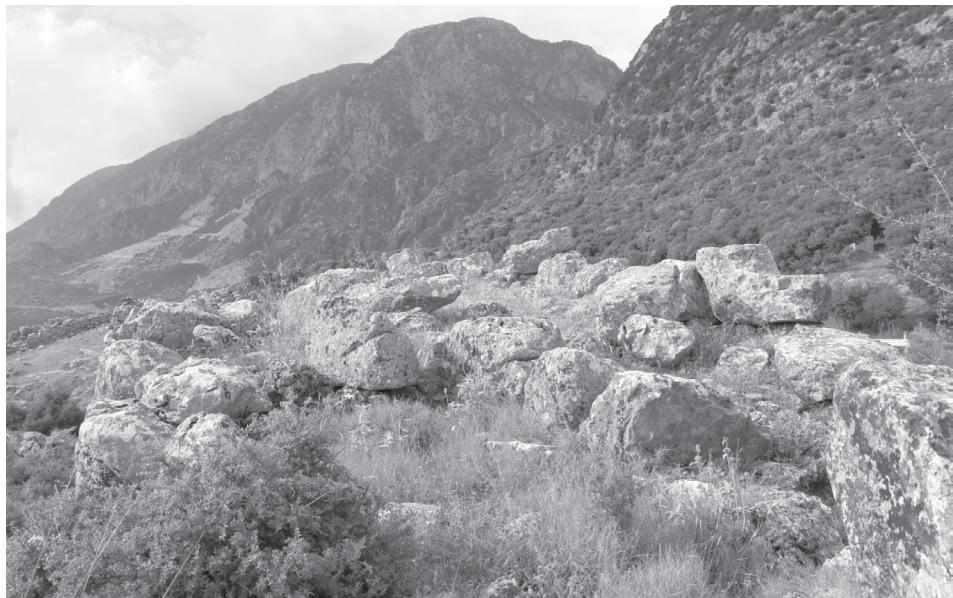
Fig. 2. The battery, looking north. On the right is the outer face of the curtain, in the middle of the photo is the original inner face of the wall and on the left is the extension.

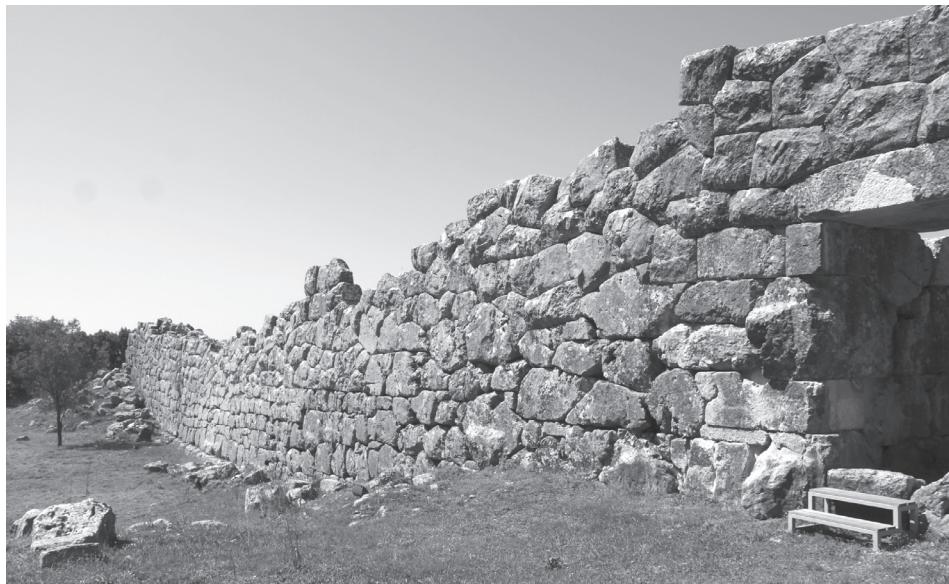
Fig. 3. General view of the southern part of the eastern curtain wall as seen from the outside. View towards the southwest.

to 4-5 meters high (Fig. 3). While the outer face of the wall has been built on relatively level ground, the inner face traverses highly uneven terrain. The landscape first descends steeply from the southern hillock to a relatively deep valley ca. 13 m wide, before ascending another hill, upon which the gateway and the northern half of the curtain has been built. Thus the inner face of the curtain spanning the valley is much higher than the outer face, ca. 7 m versus ca. 5 m (Fig. 4). This curtain is also extremely thick: The flat-topped foundation spans the lowest part of the valley at ca. 552 masl, roughly three meters lower than the similarly flat topped foundation of the outer face. On both sides the footing protrudes some 10-20 cm from the wall. The wall thickness at the foundation level is 4.85-4.93 m, while the following “middle layer” with a notably uneven top is ca. 4.6 m thick.⁸

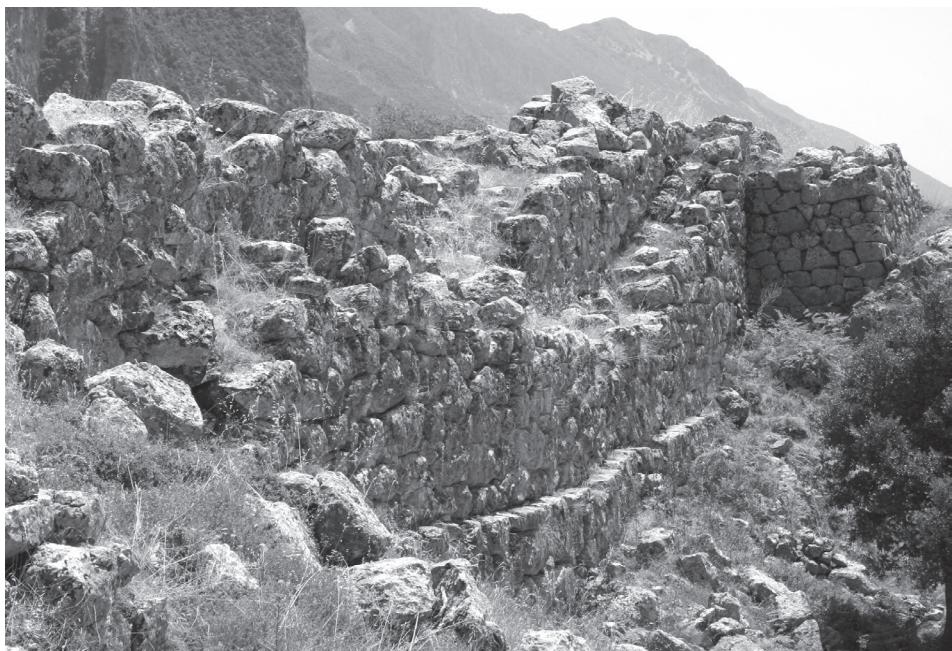
Fig. 4. The differing thicknesses of the eastern curtain. In the background is the battery. Looking southeast.

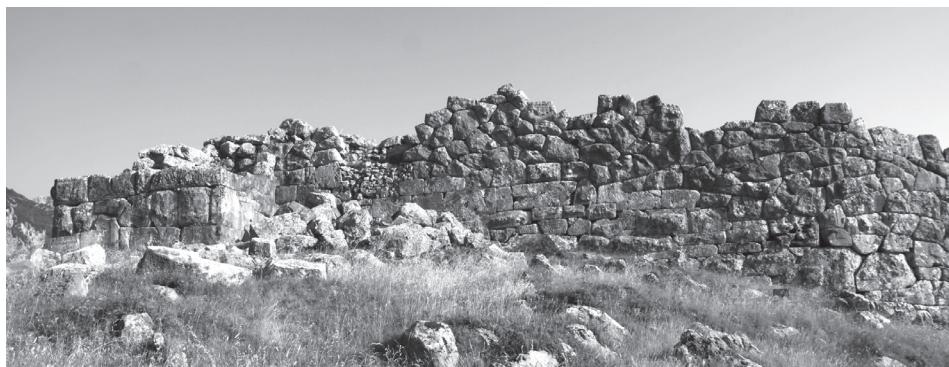
Fig. 5. The northeastern curtain and the tower, seen on the left. View towards the south.

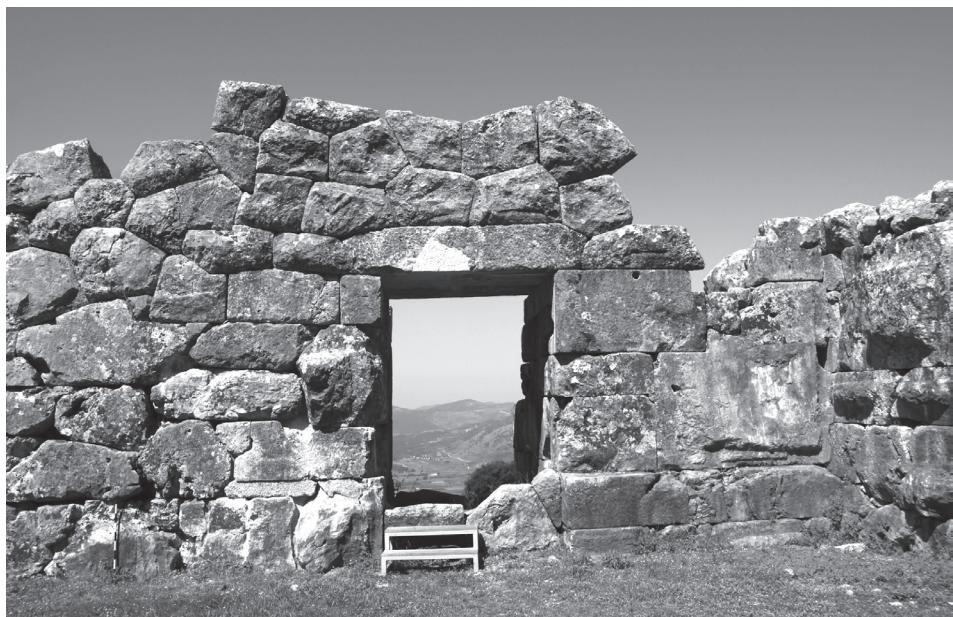
Fig. 6. The Eastern Gate seen from the outside, looking west. The monolithic threshold block, now disappeared, sat on top of the blocks, just behind the modern steps.

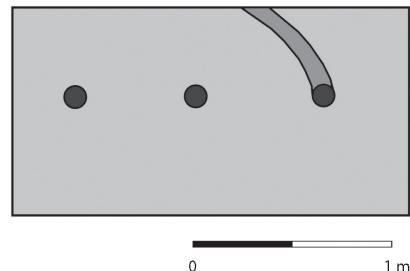
Fig. 7. The threshold block. After Hammond 1967, pl. 22, 3b.

Hammond made a sketch of the gate and, most importantly, of the large monolithic threshold block therein.²⁶ This block has since disappeared, but Hammond's sketch of the block helps in recreating what the gate originally looked like (Fig. 7). The threshold block sat on top of the uneven blocks described earlier. Its top would have sat slightly higher than the tops of the adjacent blocks on either side of the opening. If this was the case, the height of the corridor would have been around 2.5 m. Such an opening would usually have been covered by a two-leaved, inward-opening gate, with both leaves ca. 1 m wide, but in this case the drawing offers clues to a different arrangement (Fig. 7).

The first hole, on the left hand side, would have been the pivot hole on which the one-leaved gate turned, and the second a locking hole in the middle of the gate. The third one, with the curved groove leading away from it, was connected with the outer edge of the gate. A gate this large would no doubt have been quite heavy, and thus it seems that its outer edge was supported by a knob, which moved along the groove. The groove also indicates that the gate would have opened inwards. There are no traces of matching

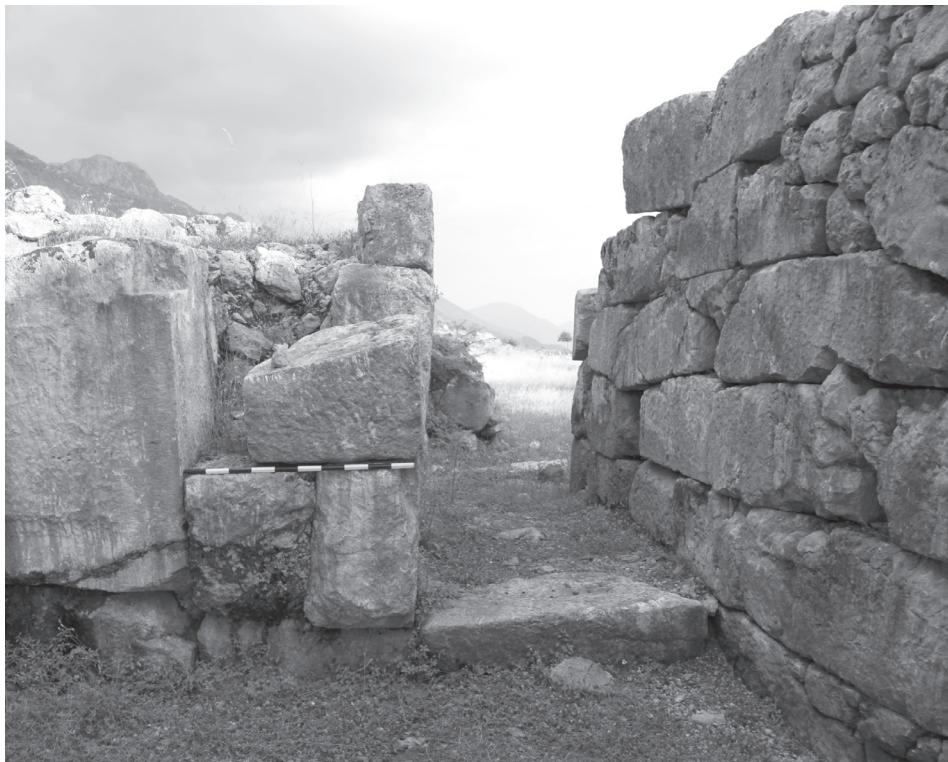
Fig. 8. The Northeastern Gate seen from the outside, looking south. The huge original corner block of the gateway is visible in the left-hand corner. The measuring stick rests on the later structure, built to reduce the width of the corridor.

The Northeastern Gate is situated at the junction of the northeastern and northern curtains, so that the northern wall would have protected all approaches to it. This gateway is interesting, as it seems to have been reduced to half its original size at some point (Fig. 8). Originally the opening was 2.2 m wide, as indicated by the huge, now cracked block situated on the eastern side of the gate. At some stage the width of the opening was reduced by one meter using relatively small, quadrangular blocks. The reduction was made by building directly on top of the original two-piece threshold block. Similarly to the Eastern Gate, the floor of the corridor was built slightly higher than the ground level. Again, no traces of bolts, jambs or pivot holes are visible in the threshold or in the adjacent walls. Thus it is impossible to say, whether the original gate was one- or two-leaved. Nevertheless, after the reduction the now ca. 1.2 m wide gate would most likely have been one-leaved.

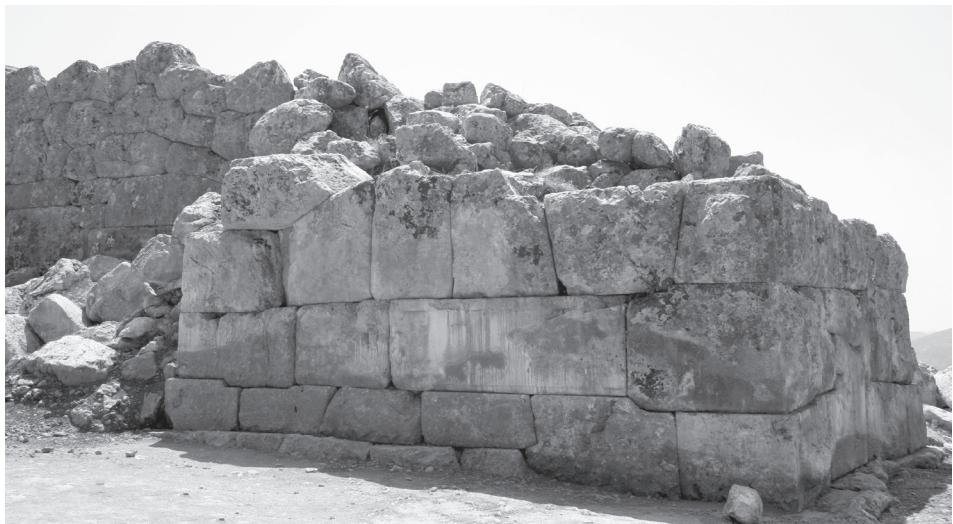
Fig. 9. The tower, looking southwest.

The tower is built on a level footing course which protrudes ca. 30 cm from the walls, especially near the southeastern and northeastern corners. In the northeastern corner the foundation extends up to 50 cm from the line of the walls.

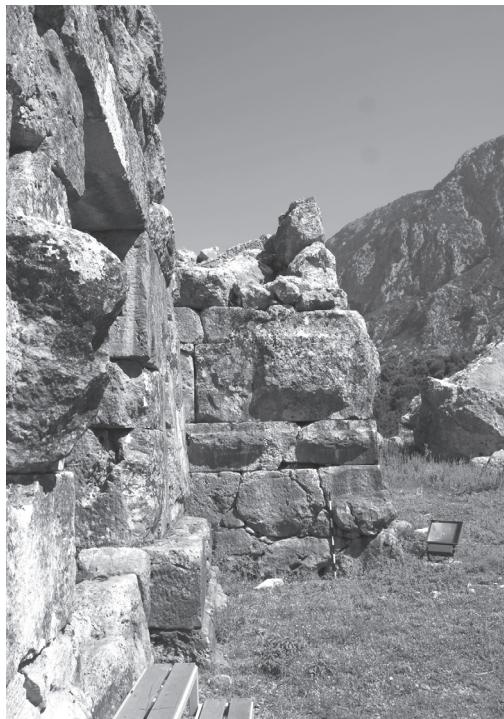
Fig. 10. The jog protecting the Eastern Gate, indicated by the flight of steps on the foreground. View towards the north.

turn, protruding some 2.3 m; this jog is built to protect the gate (Fig. 10). Flanking fire could thus be directed to the unshielded right side of the enemy approaching it.³⁰

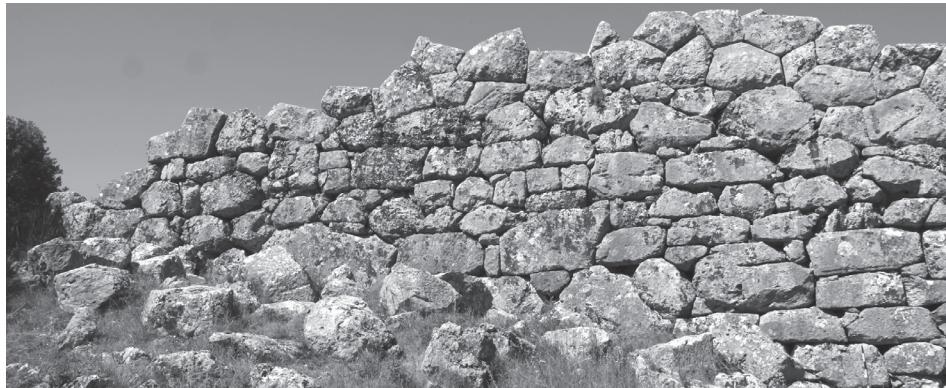
Fig. 11. The masonry in the southern end of the eastern curtain, on the left, is coarser than the one found in the following sectors. View towards the west.

1.0 m wide). The blocks have a rough appearance since the joints are very crude, leaving wide gaps around the blocks. The surface of the blocks is slightly smoothed, creating a so called tooled face³⁷ (Fig. 11). This kind of masonry slowly gives way to a different kind of masonry as the wall progresses toward the north.

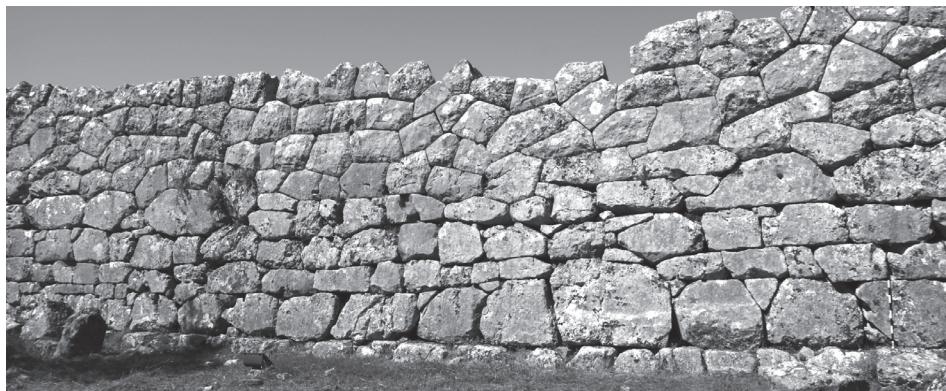
Fig. 12. The masonry in the outer face of the eastern curtain. Note at the bottom the shallow footing course with a level top, the following large, tooled-faced masonry, above which is the neat, quarry- or hammer-faced polygonal masonry. The frequency of triangular plugs in the lower section is also noteworthy.

As the wall descends the hill the masonry in the wall changes (Fig. 12). A flat topped foundation layer protruding ca. 0.2-0.3 m from the wall is built across the lowest sector of the fortifications, disappearing from view when the ground starts to rise close to the gateway. Built on top of the foundation layer is the thick lower part of the wall, ca. 2-3 m high. It consists of tooled faced blocks, predominantly oblong and somewhat more quadrangular than the masonry on the hillock. Some of the blocks have keying.³⁸ The size of blocks ranges from small (ca. 0.6 x 0.6, 0.3 x 0.7 m) to massive (ca. 0.9 x 1.2, 1.2 x 1.4 m). Due to the shape of the blocks, the horizontal joints can run straight for several meters. Most of the joints are gaping wide, but some of the straight joints can be relatively tight. The largest gaps in the seams are filled using small plug-stones. The plugs are usually located on the top of a masonry course, where they fill a hole between two irregular blocks. Most of the plugs are triangular in shape, standing on their apex between two blocks. Occasionally the plugs are quadrangular, but again they are placed on the upper part of the course (see Fig. 12). This kind of frequent use of plugs has several parallels in the Peloponnese.³⁹ Plugs are also present in the neighbouring fortress of Agios Donatos, in the internal walls of the tower and in the outside face of the curtain adjacent to the southeastern gate.⁴⁰

⁶¹ Randsborg 2002, 222-227, figs. IX, 21-26. Compare especially Randsborg's figs. IX, 25-26 with Figs. 12 and 18. This kind of masonry seems indeed to be the most popular one in this part of Greece: In addition to the examples given by Randsborg, I have observed similar masonry at Paramythia, Agios Donatos, Polyneri (Koutsi), Dhimokastro and Kastritsa, to name a few.

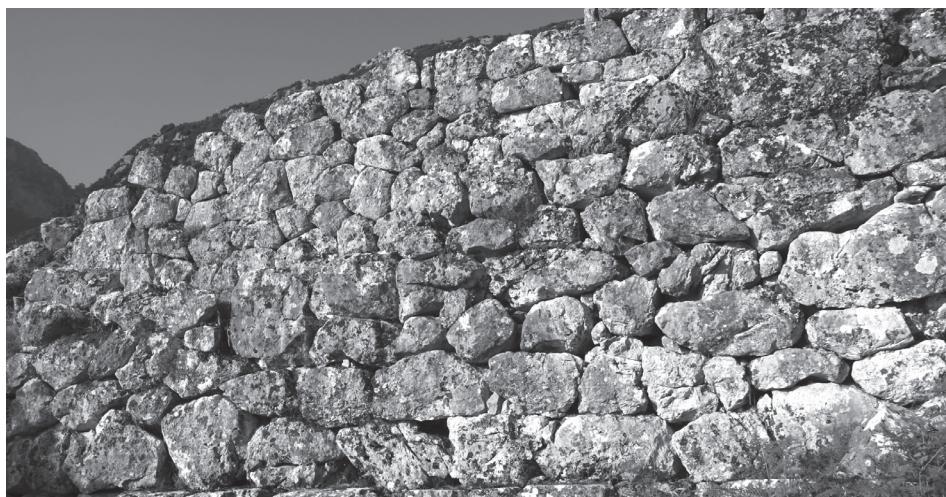
Fig. 13. The inner face of the same curtain. Note the protruding foundation with level top at the bottom, the rough appearance of the following section and the slightly more accurate finish in the thinner upper part.

The masonry used on the inside face of the curtain is again different from that previously mentioned (Fig. 13). The thick lower part of the wall is built of large, slightly rounded, hammer faced blocks with loose, gaping joints, while the masonry of the upper part is similar to the outside face, although slightly coarser with loose joints.

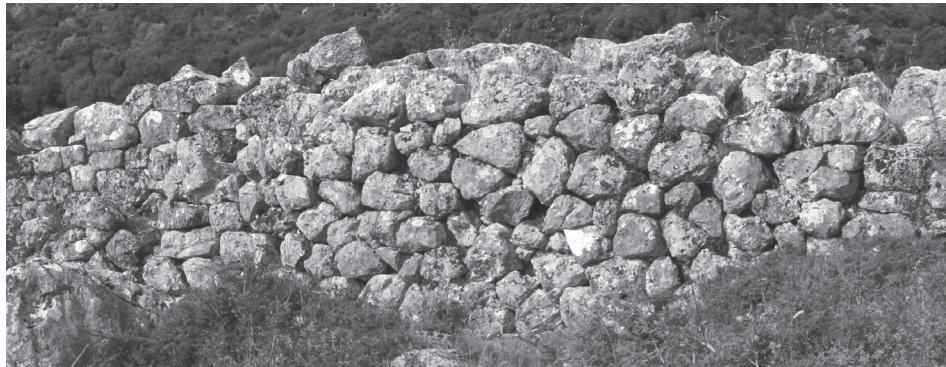
Fig. 14. The inside face of the bastion. Note how extremely rough the masonry and the joints are, when compared to the adjacent curtain, visible on the left and in Fig. 13.

The inside face of the battery consists of even rougher masonry, almost resembling dry rubble.⁴² The blocks are rounded, bulging, quarry faced, while the joints are extremely loose, with large gaping holes between all the blocks. It almost seems that the stones used were just picked up from the ground in their natural state, without any fashioning (Fig.

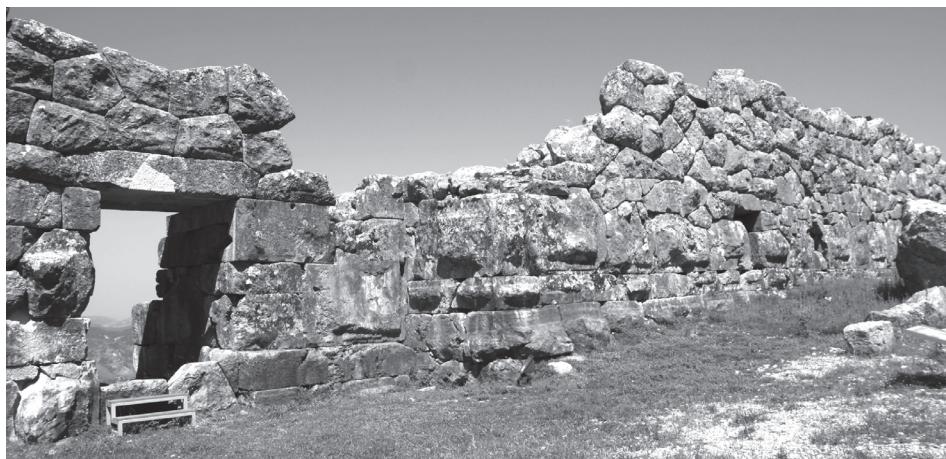
Fig. 15. The outer face of the northeastern curtain. The huge block mentioned in the text sits on top of the foundation, next to the jog. Note how different the masonry is in this area.

The masonry around and to the north of the Eastern Gate is notably different (Fig. 15). The curtain has a very distinct protruding, level topped foundation, a middle section consisting of peculiar masonry not found in other sectors, while the upper part again consists of similar neatly finished medium sized polygonal masonry as described previously.

block forms the corner with the jog in the wall. All the blocks are neatly cut and the joints are tight. Most of the blocks used in the lower part of this sector are different from the ones used in the previous sector in that they have a very strongly bulging, hammer-faced rustication in the center of the block and up to 20-30 cm wide, tooled margins on all sides (Fig. 16). The central rustication can bulge outwards for up to ca. 15 cm.⁴³ Some tooled faced large blocks are still present, but they are a minority. The lintel block of the gate is tooled faced, low but very oblong (ca. 0.5 x 2.5 m), nearly quadrangular in shape. A few large holes in the masonry seem to have held blocks, now disappeared (Fig. 15).

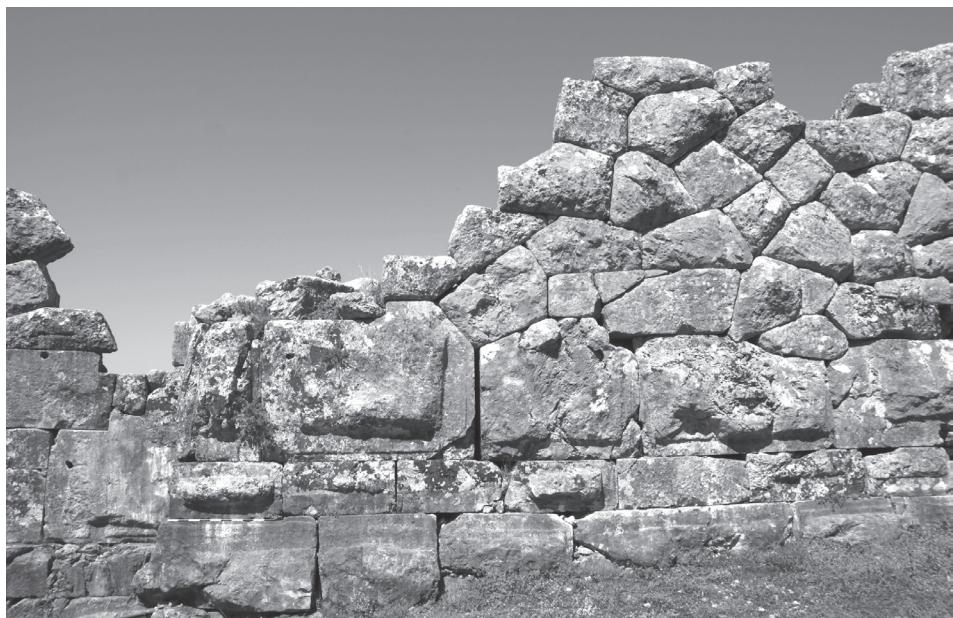
Fig. 16. The masonry used in the lower section of wall between the jog and the tower is very different. Large blocks have wide tooled margins, while the hammered central panel bulges very strongly. The footing course has a wide, smooth band along the upper edges of the blocks.

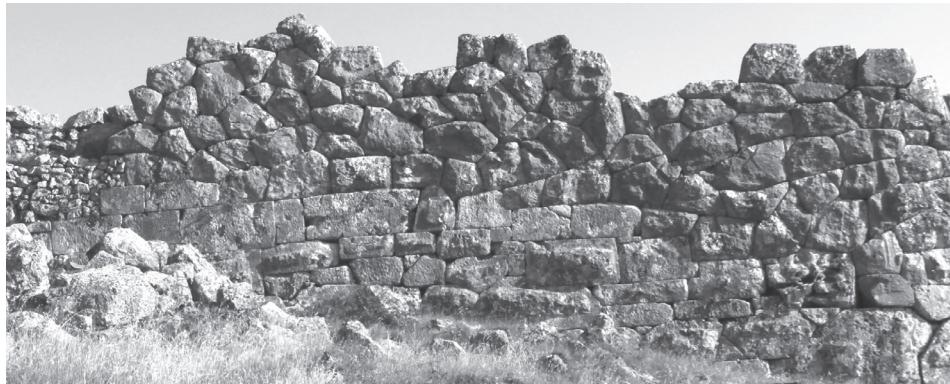
Fig. 17. The masonry styles in the eastern half of the northeastern curtain, looking south.

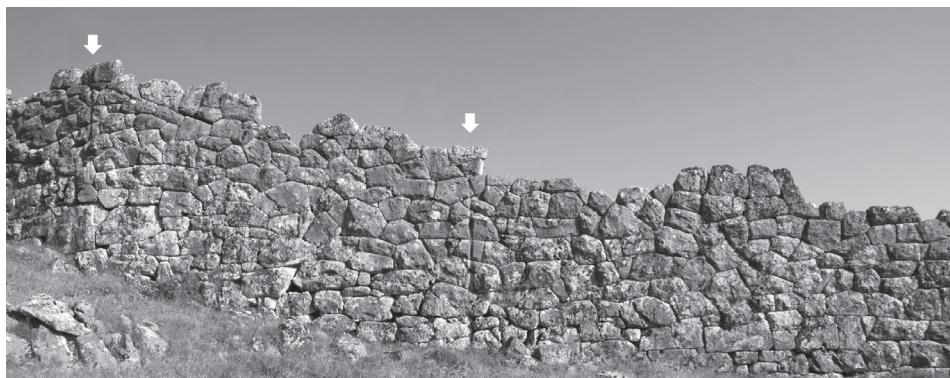
Fig. 18. The masonry styles after the bend. Note how, in the center of the photo, the masonry of the upper part stretches almost down to ground level. The arrows indicate the presence of two of the three vertical grooves in this curtain. View towards the south.

of the upper part, stretching almost to the ground (Fig. 18). Close to the Northeastern Gate the masonry changes again. The huge block forming the corner of the curtain and the gateway has approximately 20 cm wide smooth margins all over, while the central panel with rustication is fairly shallow, almost tooled. The block has cracked and recently been supported by wooden beams.

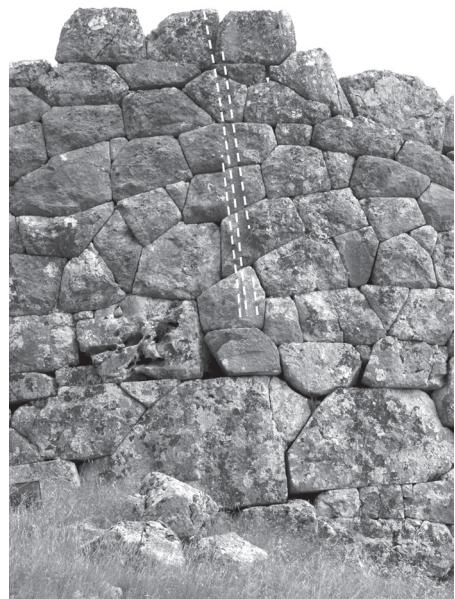
Fig. 19. The crooked groove cut into the bend of the northeastern curtain. The cuts are indicated by the dashed line.

There are three vertical grooves cut into the masonry in this curtain, one across the upper part of the wall at the bend, another stretching all the way to the ground in the middle of the following straight sector and a third, short one approximately two thirds across. The one in the bend of the curtain is peculiar in being very crooked, not even nearly vertical (Fig. 19). There is a slightly shallower cut on the eastern side of the groove, as if the masons may have tried to straighten it.⁴⁵

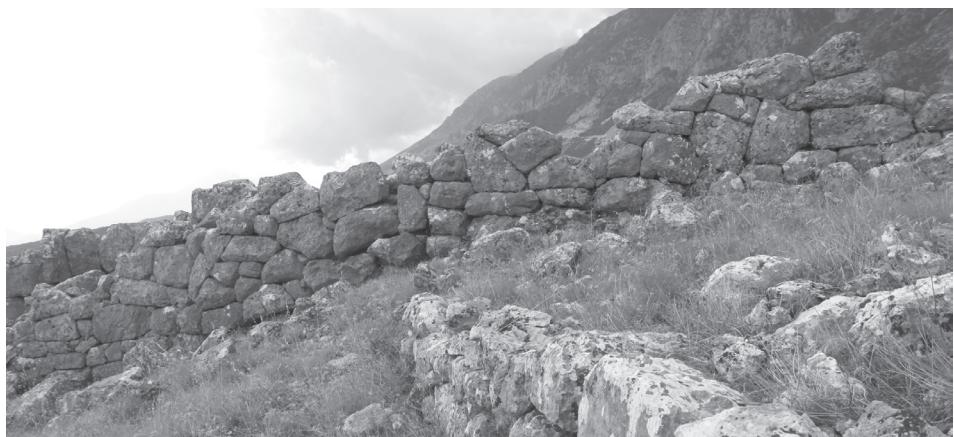
Fig. 20. Masonry on the inside of the northeastern curtain. In the foreground is a terrace wall. View towards the north.

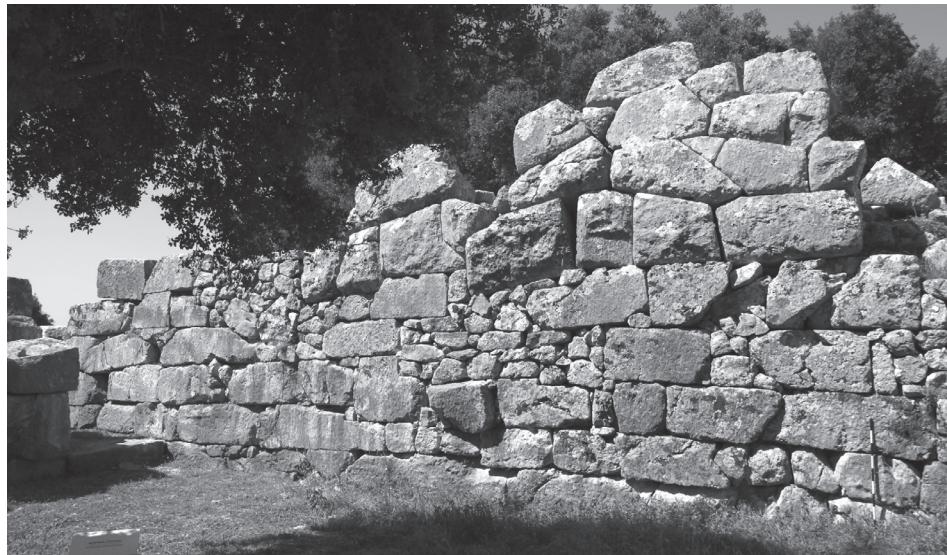
Fig. 21. The best preserved stretch of the northern curtain, showing the masonry styles used. On the left, the Northeastern Gate is just visible. The restorers have filled the holes in the wall with small stones. View towards the southwest.

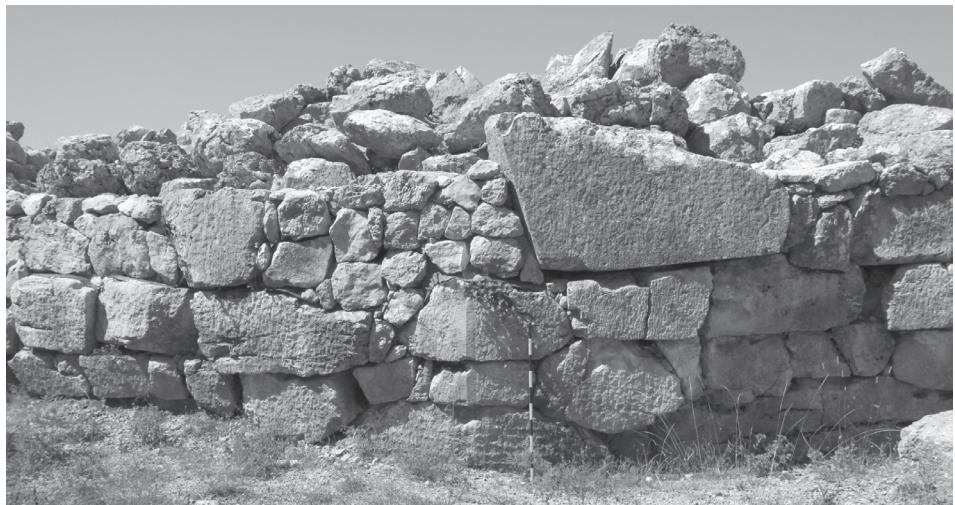
Fig. 22. The bend in the northern curtain is visible in the center of the photo. Note the smooth band defining the corner, visible to the left of the stick. View towards the west.

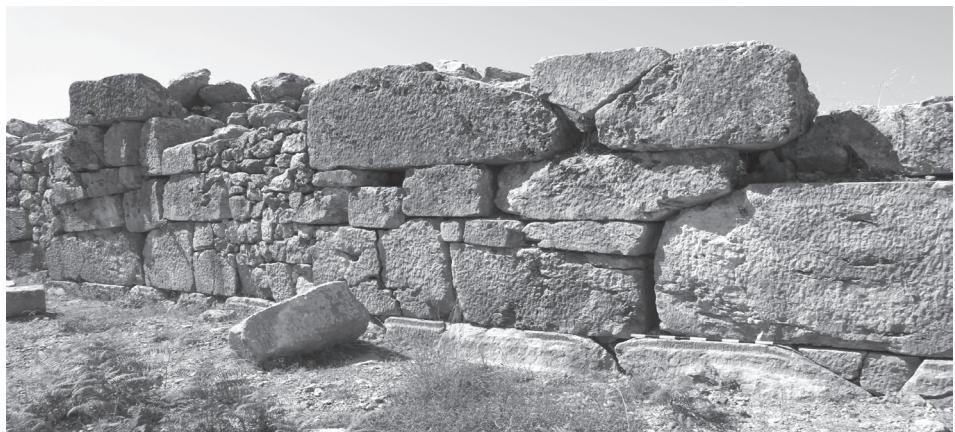
Fig. 23. The curtain has a peculiar footing course, seen below the stick. All the blocks in the footing have a smooth band on their upper sides. View towards the southwest.

Eastern Gate, although in a greatly reduced scale. Here, despite the fact that the foundation blocks are oblong and very large, the smooth upper margin of the blocks is only ca. 5 cm wide and the whole footing only protrudes some 5 cm from the wall (Fig. 23).

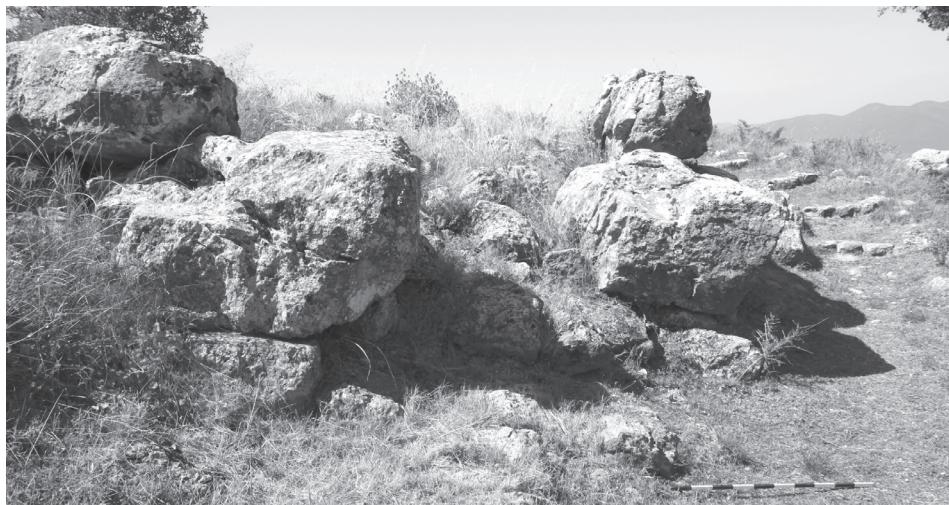
Fig. 24. The remains of the salient in the northeastern corner. The modern pathway over the curtain can be seen on the right. View towards the west.

The last few meters of the curtain have almost disappeared, but it seems that the few remaining blocks forming the salient in the northern corner are more rounded and bulging than any other blocks (Fig. 24). This might, of course, be due simply to the present condition of the salient, as only the largest and crudest blocks are left in place. The inside face of this curtain is not visible as it is still covered by fallen blocks, so no identification of the masonry there can be made. Likewise, the last stretch of curtain on the edge of the northern cliff is so badly destroyed and covered that nothing can be said of the masonry styles used, other than that the few visible blocks in the inside face are tooled-faced polygonal. On the external face the fallen blocks prevent us from making observations.
